**DEPARTMENT OF TRANSPORTATION**

Contract #: 04-0120F4Cty: SF/ALA Rte: 80 PM: 13.2/13.9File #: 1.28**WELDING INSPECTION REPORT****Resident Engineer:** Casey, William**Address:** 333 Burma Road**City:** Oakland, CA 94607**Report No:** WIR-028260**Date Inspected:** 17-Aug-2012**Project Name:** SAS Superstructure**OSM Arrival Time:** 700**Prime Contractor:** American Bridge/Fluor Enterprises, a JV**OSM Departure Time:** 1900**Contractor:** American Bridge/Fluor Enterprises, a JV**Location:** Job Site**CWI Name:** As noted below**CWI Present:** Yes No**Inspected CWI report:** Yes No N/A**Rod Oven in Use:** Yes No N/A**Electrode to specification:** Yes No N/A**Weld Procedures Followed:** Yes No N/A**Qualified Welders:** Yes No N/A**Verified Joint Fit-up:** Yes No N/A**Approved Drawings:** Yes No N/A**Approved WPS:** Yes No N/A**Delayed / Cancelled:** Yes No N/A**Bridge No:** 34-0006**Component:** SAS OBG**Summary of Items Observed:**

13E PP120-E2.0-FBW1 (Exterior)

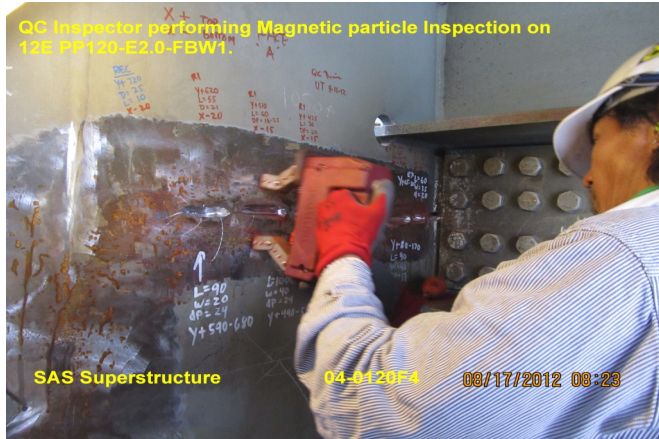
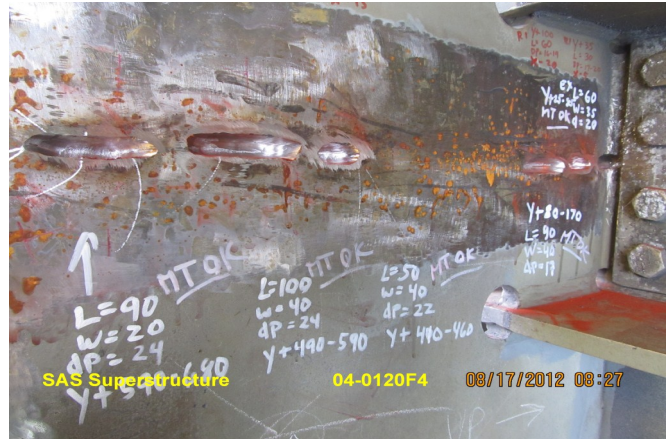
This QA Inspector randomly observed the excavation operations of Ultrasonic rejectable indications on the horizontal Complete Joint Penetration (CJP) joint of Seismic Performance Critical Member (SPCM) material at 13E PP120-E2.0-FBW1 on the exterior of the OBG. This QA Inspector observed ABF/JV qualified welder Chris Bowles #9317 performing the Carbon Arc Gouging (CAG) method to remove metal from the material. The welder was observed cleaning up the excavations utilizing a small disc grinder and a de-burring drill. Upon completion of the excavations, Quality Control (QC) Inspector Salvador Merino performed a Magnetic Particle Inspection (MT) of the sites to determine soundness of the metal and observed no indications, QC then measured the dimensions of the excavations for length, width and depth.

This QA Inspector recorded the dimensions of the excavations as:

Y+25mm: 60mm in length, 35mm wide and 20mm deep.

Y+80mm: 90mm in length, 40mm wide and 17mm deep.

Y+410mm: 50mm in length, 40mm wide and 22mm deep.

Y+490mm: 100mm in length, 40mm wide and 24mm deep.

Y+590mm: 90mm in length, 20mm wide and 24mm deep.

The total length of the weld measured 870mm with the total accumulative length of the excavations of 390mm which exceeded the allowable length by 90mm. The thickness of the member was measured as 30mm with four (4) of five (5) excavations greater than 65% depth of the members thickness. (See photo below). This QA Inspector generated a TL-15 incident report on this date for a critical weld repair.
